# **Field Report for Airborne Data Collected In Support of US EPA Region 6 Intercontinental Terminals Company LLC Fire 9 April 2019**

## **Data Results Flight 22, 9 April 2019**

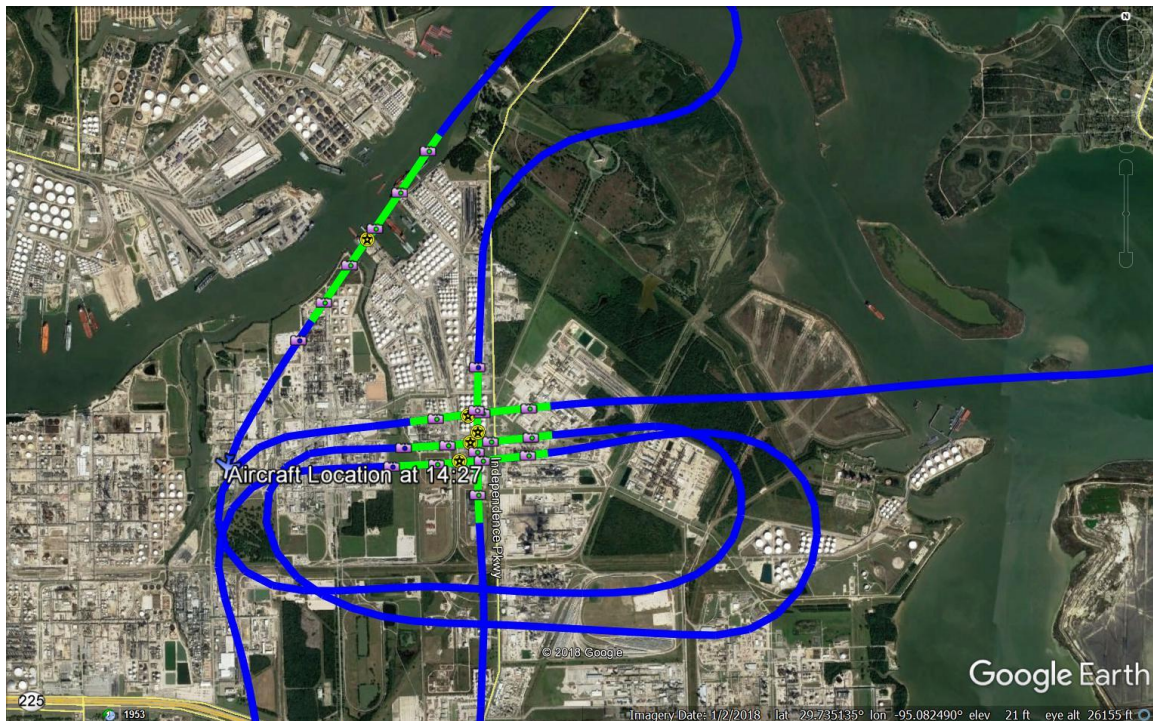
Figure 2: Flight line data for 9 April 2019, Flight 22. The blue lines represent the ASPECT flight path, green lines represent when the Infrared Line Scanner was actively collecting data, and the camera icons represent when a photo was taken.

The time for lift-off was given as 0845. The aircraft was over the site at 0915 and collected a total of 5 data collection passes over the ITC site. Flight information is summarized in Appendix A and Figure 2.

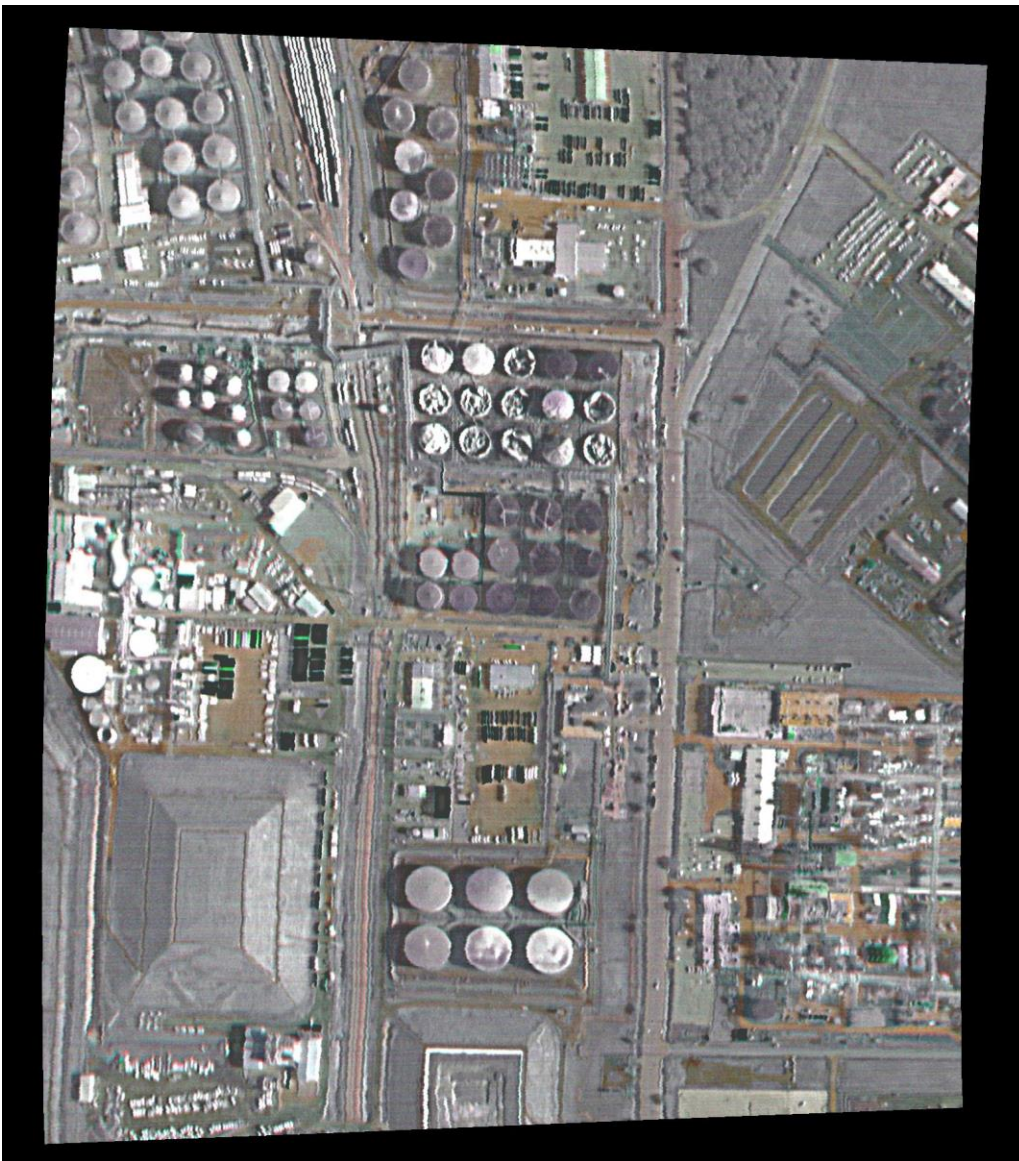
Figure 3: IR image of ITC data for 9 April 2019, Flight 22, Run 5

generated for each pass. It should be noted that due to a GPS constellation change (weeks since start), the flight log shows no IRLS collected. Data was collected and a software fix is being generated at this time. This change to the constellation only impacts the data header. Figure 3 shows a typical 3-band infrared image obtained from data collected for Run 5. Analysis of IR imagery of the tank farm shows no difference from data collected on 8 April 2019.

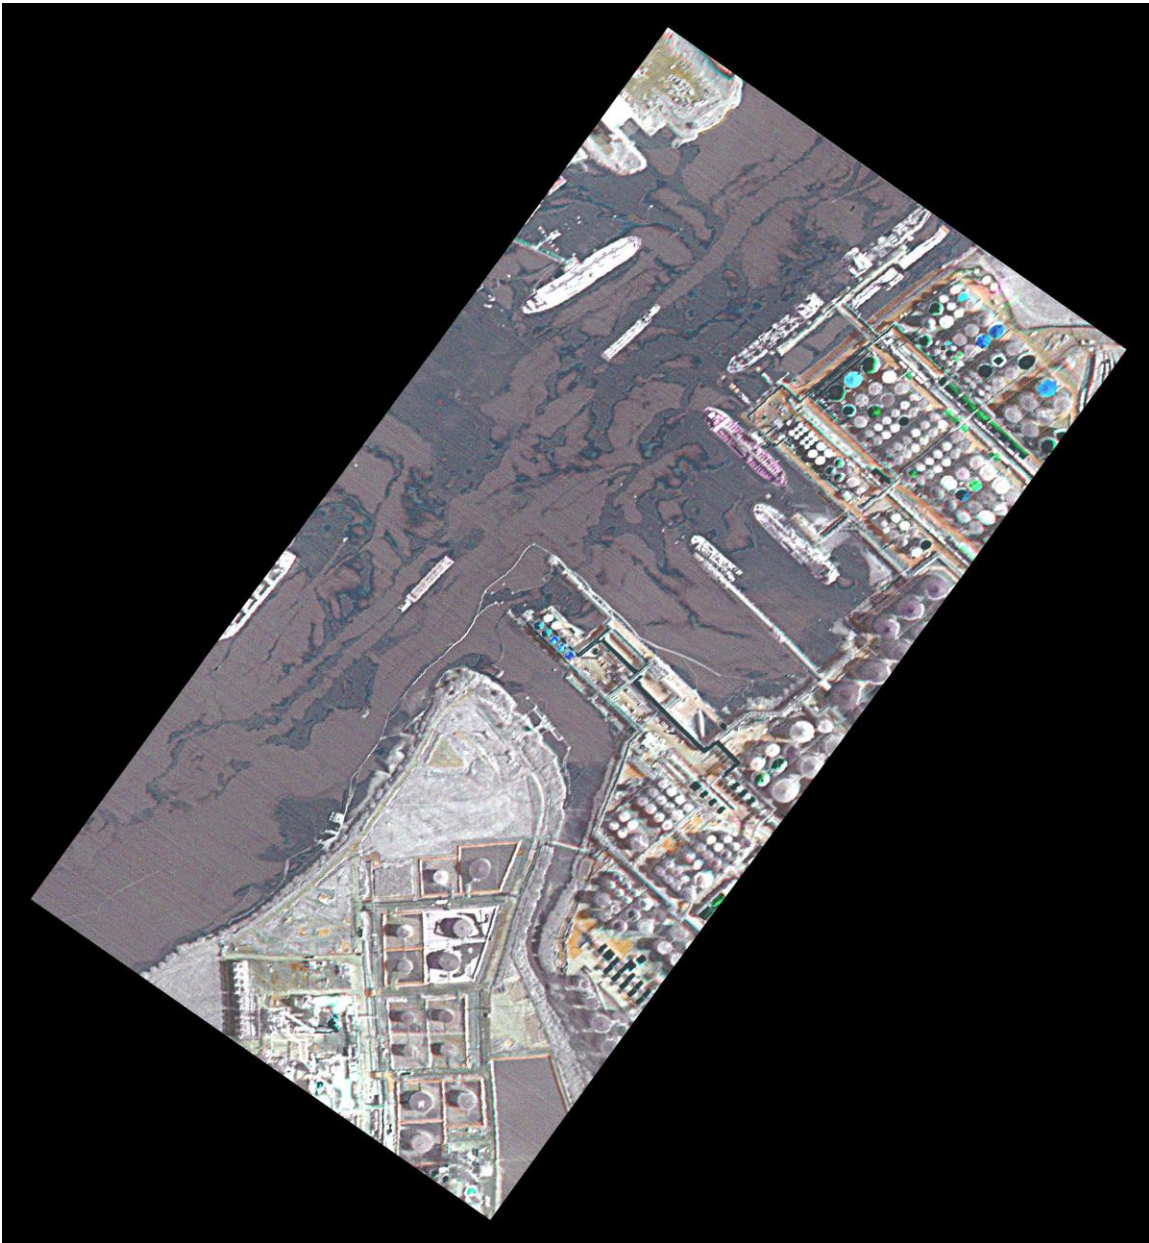
Figure 4: IR Image of Contained Oil 9 April 2019, Fight 22, Run 6

Figure 4 provides an IR image of the confluence area. Some product can be observed within the boom structure namely product pushed to south of each boom pocket. No change in the quantity of product from the flight on 8 April 2019 is evident. There does appear to be wide-spread sheen in the ship channel. The source is unclear since there appears to be no significant leakage from the booms suggesting that this may be native to the channel.

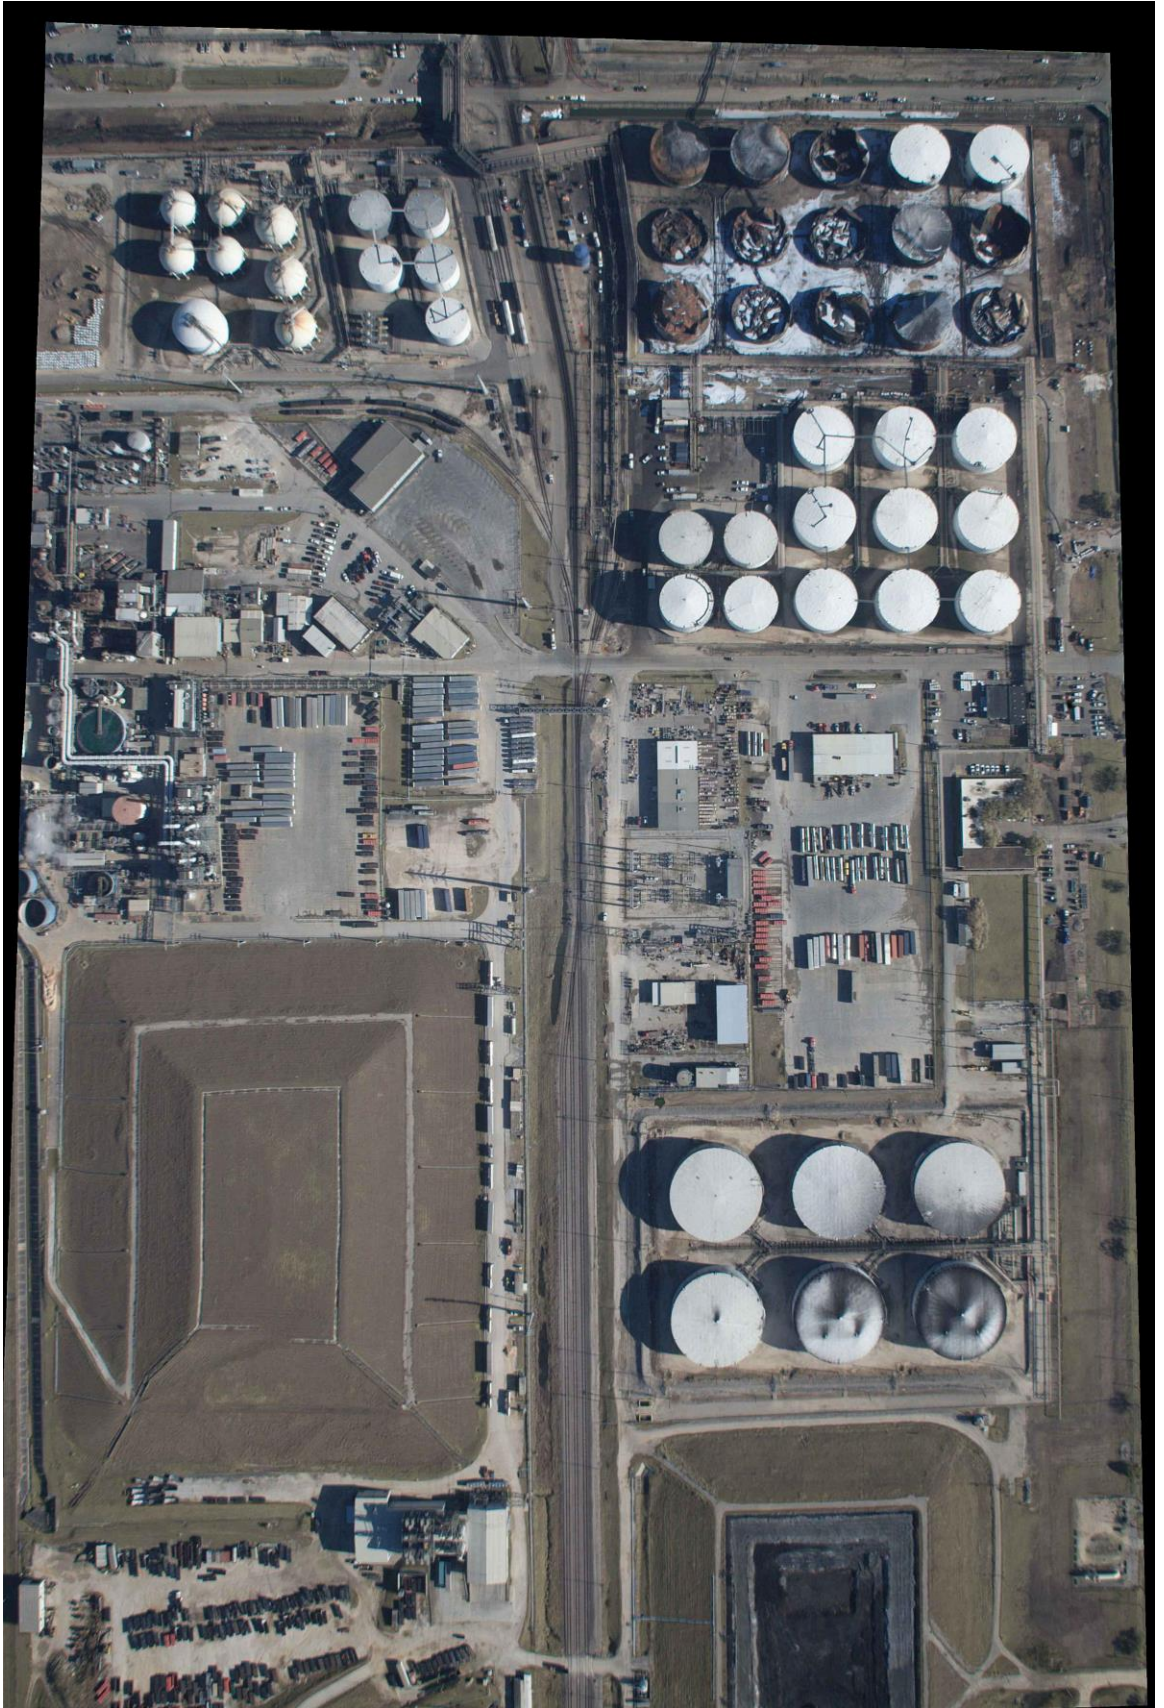
Figure 5: Aerial Image of the Tank Farm, 9 April 2019, Flight 22

A full set of high resolution aerial digital photography was collected as part of the flight. Figure 5 and 6 show representative overhead images collected as part of each pass over the tank farm. As with the flight on 8 April 2019, the scene in both the aerial and oblique shows no significant change from prior flights.

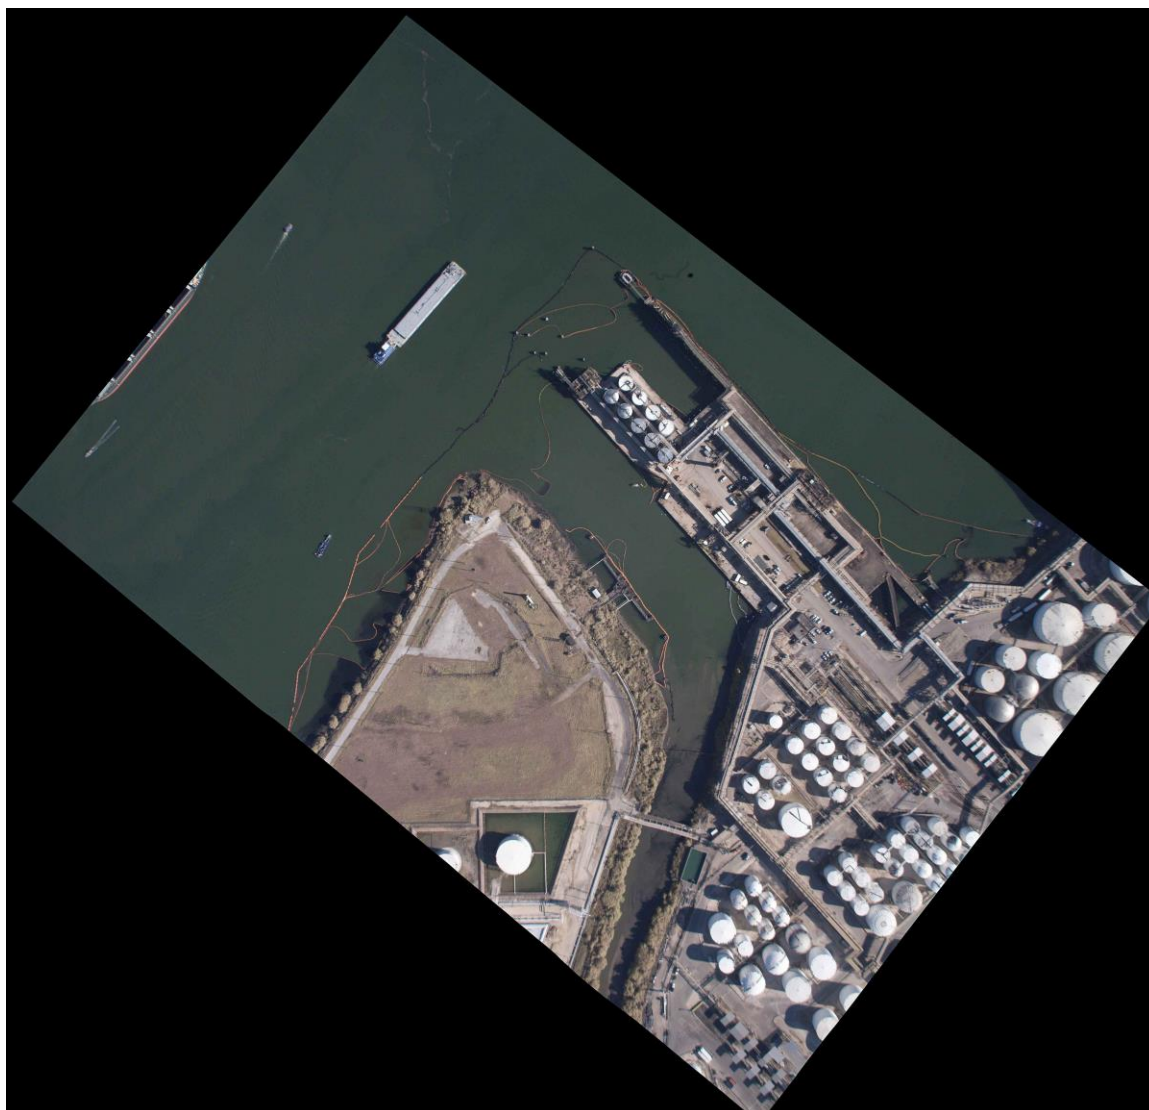
Figure 7: Aerial Image of the Ship Channel Boom Area, 9 April 2019, Flight 22

The confluence area aerial image is given in figure 7. The image confirms a small amount of product in the boom structure. The oblique image (Figure 8) provides more detail and confirms the presence of dark product in both the drainage channel and the ship channel booms. No sheen is present in the image suggesting that the sheen observed in the IR is very light.
